2nd Biennial of Architectural and Urban Restoration Integrated strategy for intervention in the Public Space of **THE HISTORIC CENTER OF VILA NOVA DE GAIA**

Gaiurb, EM Departamento de Reabilitação Urbana

Architects Duarte Rocha, Rita Amaral, Marta Gomes **Landscape Architect** Joana Magalhães
2008-2012 Vila Nova de Gaia, Portugal

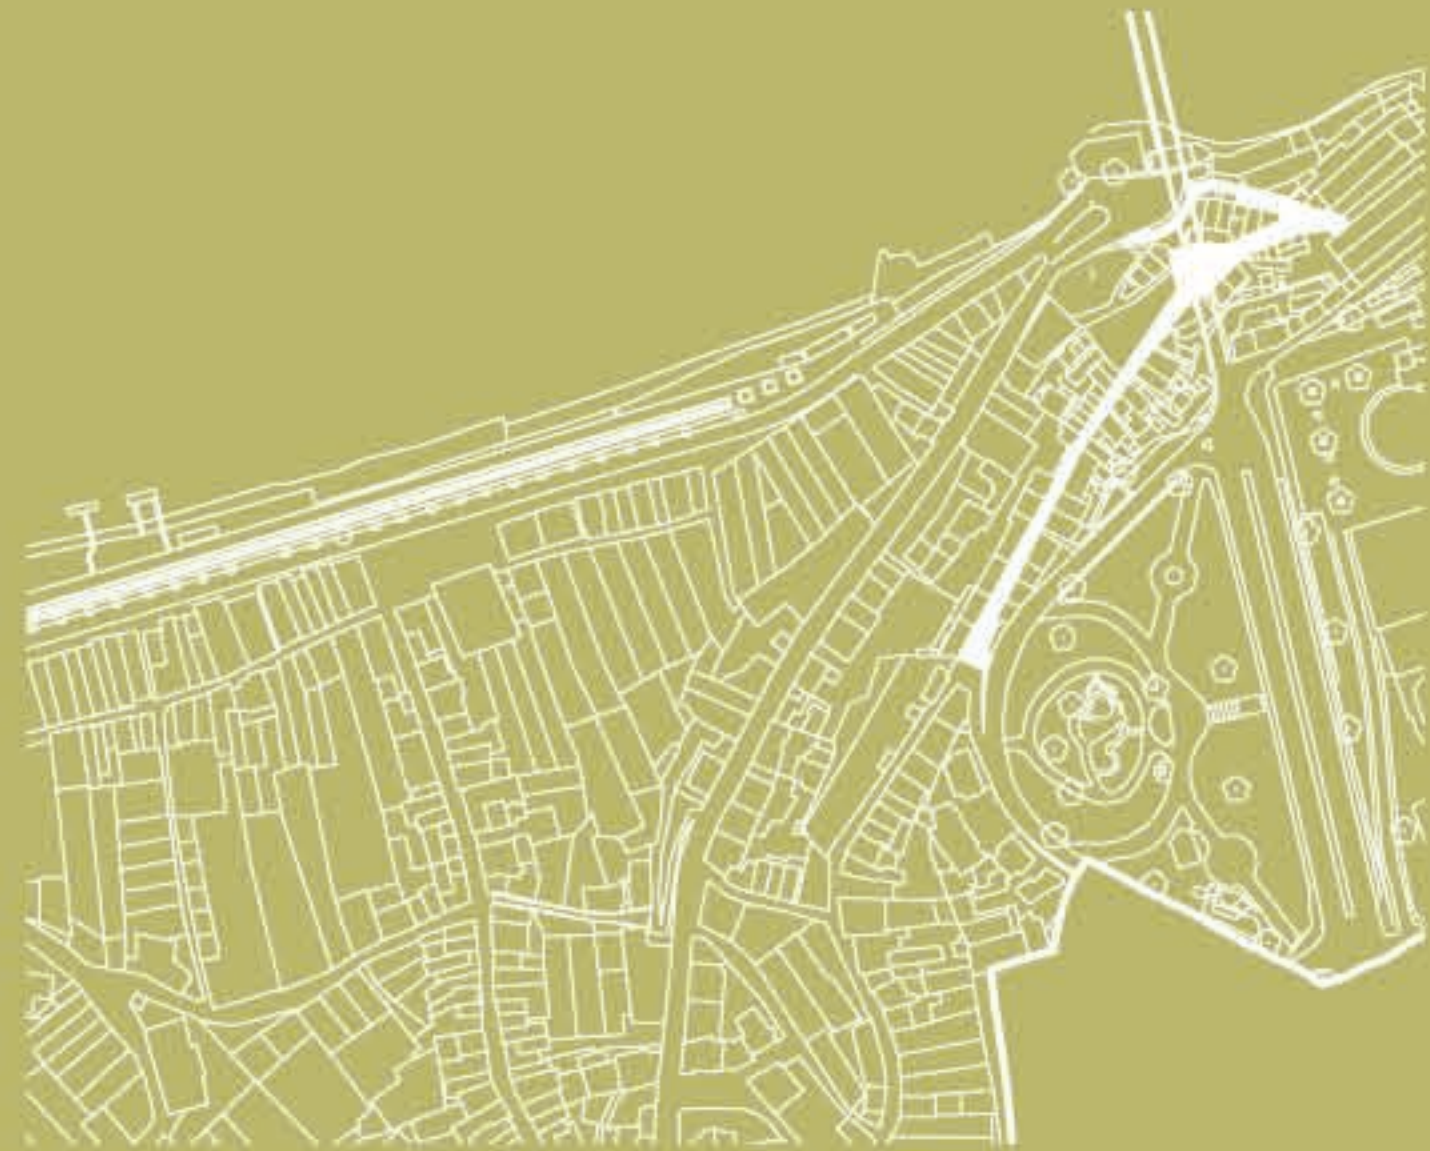
CALÇADA DA SERRA

PRE-EXISTENCE

Street with very steep slope highly used by tourist as one of the connections to the river side;
Pavement in very bad conditions composed with very old granite slabs;
Quota doorway too high for the street network;
Conflict between cars and pedestrians due to its narrow cross-section in its final term;

PROPOSAL

Introduction of a transverse element composed by a drain-water grid and a 3cm granite high guide that works as a speed bump that constrain traffic and make the descent more stable for the pedestrians;
Creation of two rows of granite cubes of 11cm and a 40cm guide along the façades. This track is occasionally interrupted in front of the door's buildings to give place to a granite slab or steps;
Choice of materials influenced by the characteristics of the street, which forced the adoption of a material that would guarantee a better grip on the pavement. The old pavement was reused to mark some relevant points such as the pillar bridge foundation;
Improvement of pedestrian circulation by the introduction of a metal suspended walkway, fixed on the outside of the street's support wall;
Element in iron, of light appearance, that allows to win space for pedestrians and increase the effect of view-point over the river and the Luis I bridge;

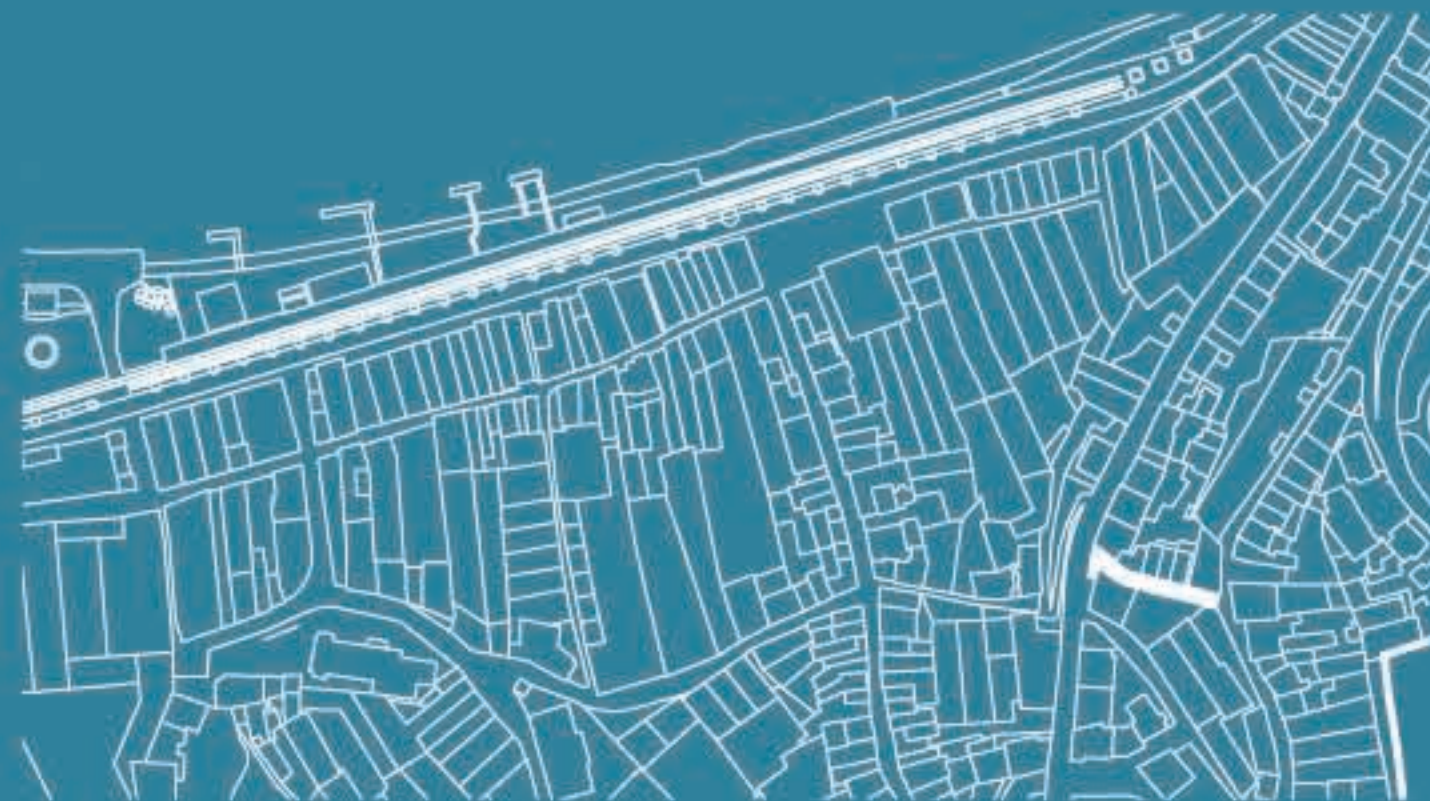
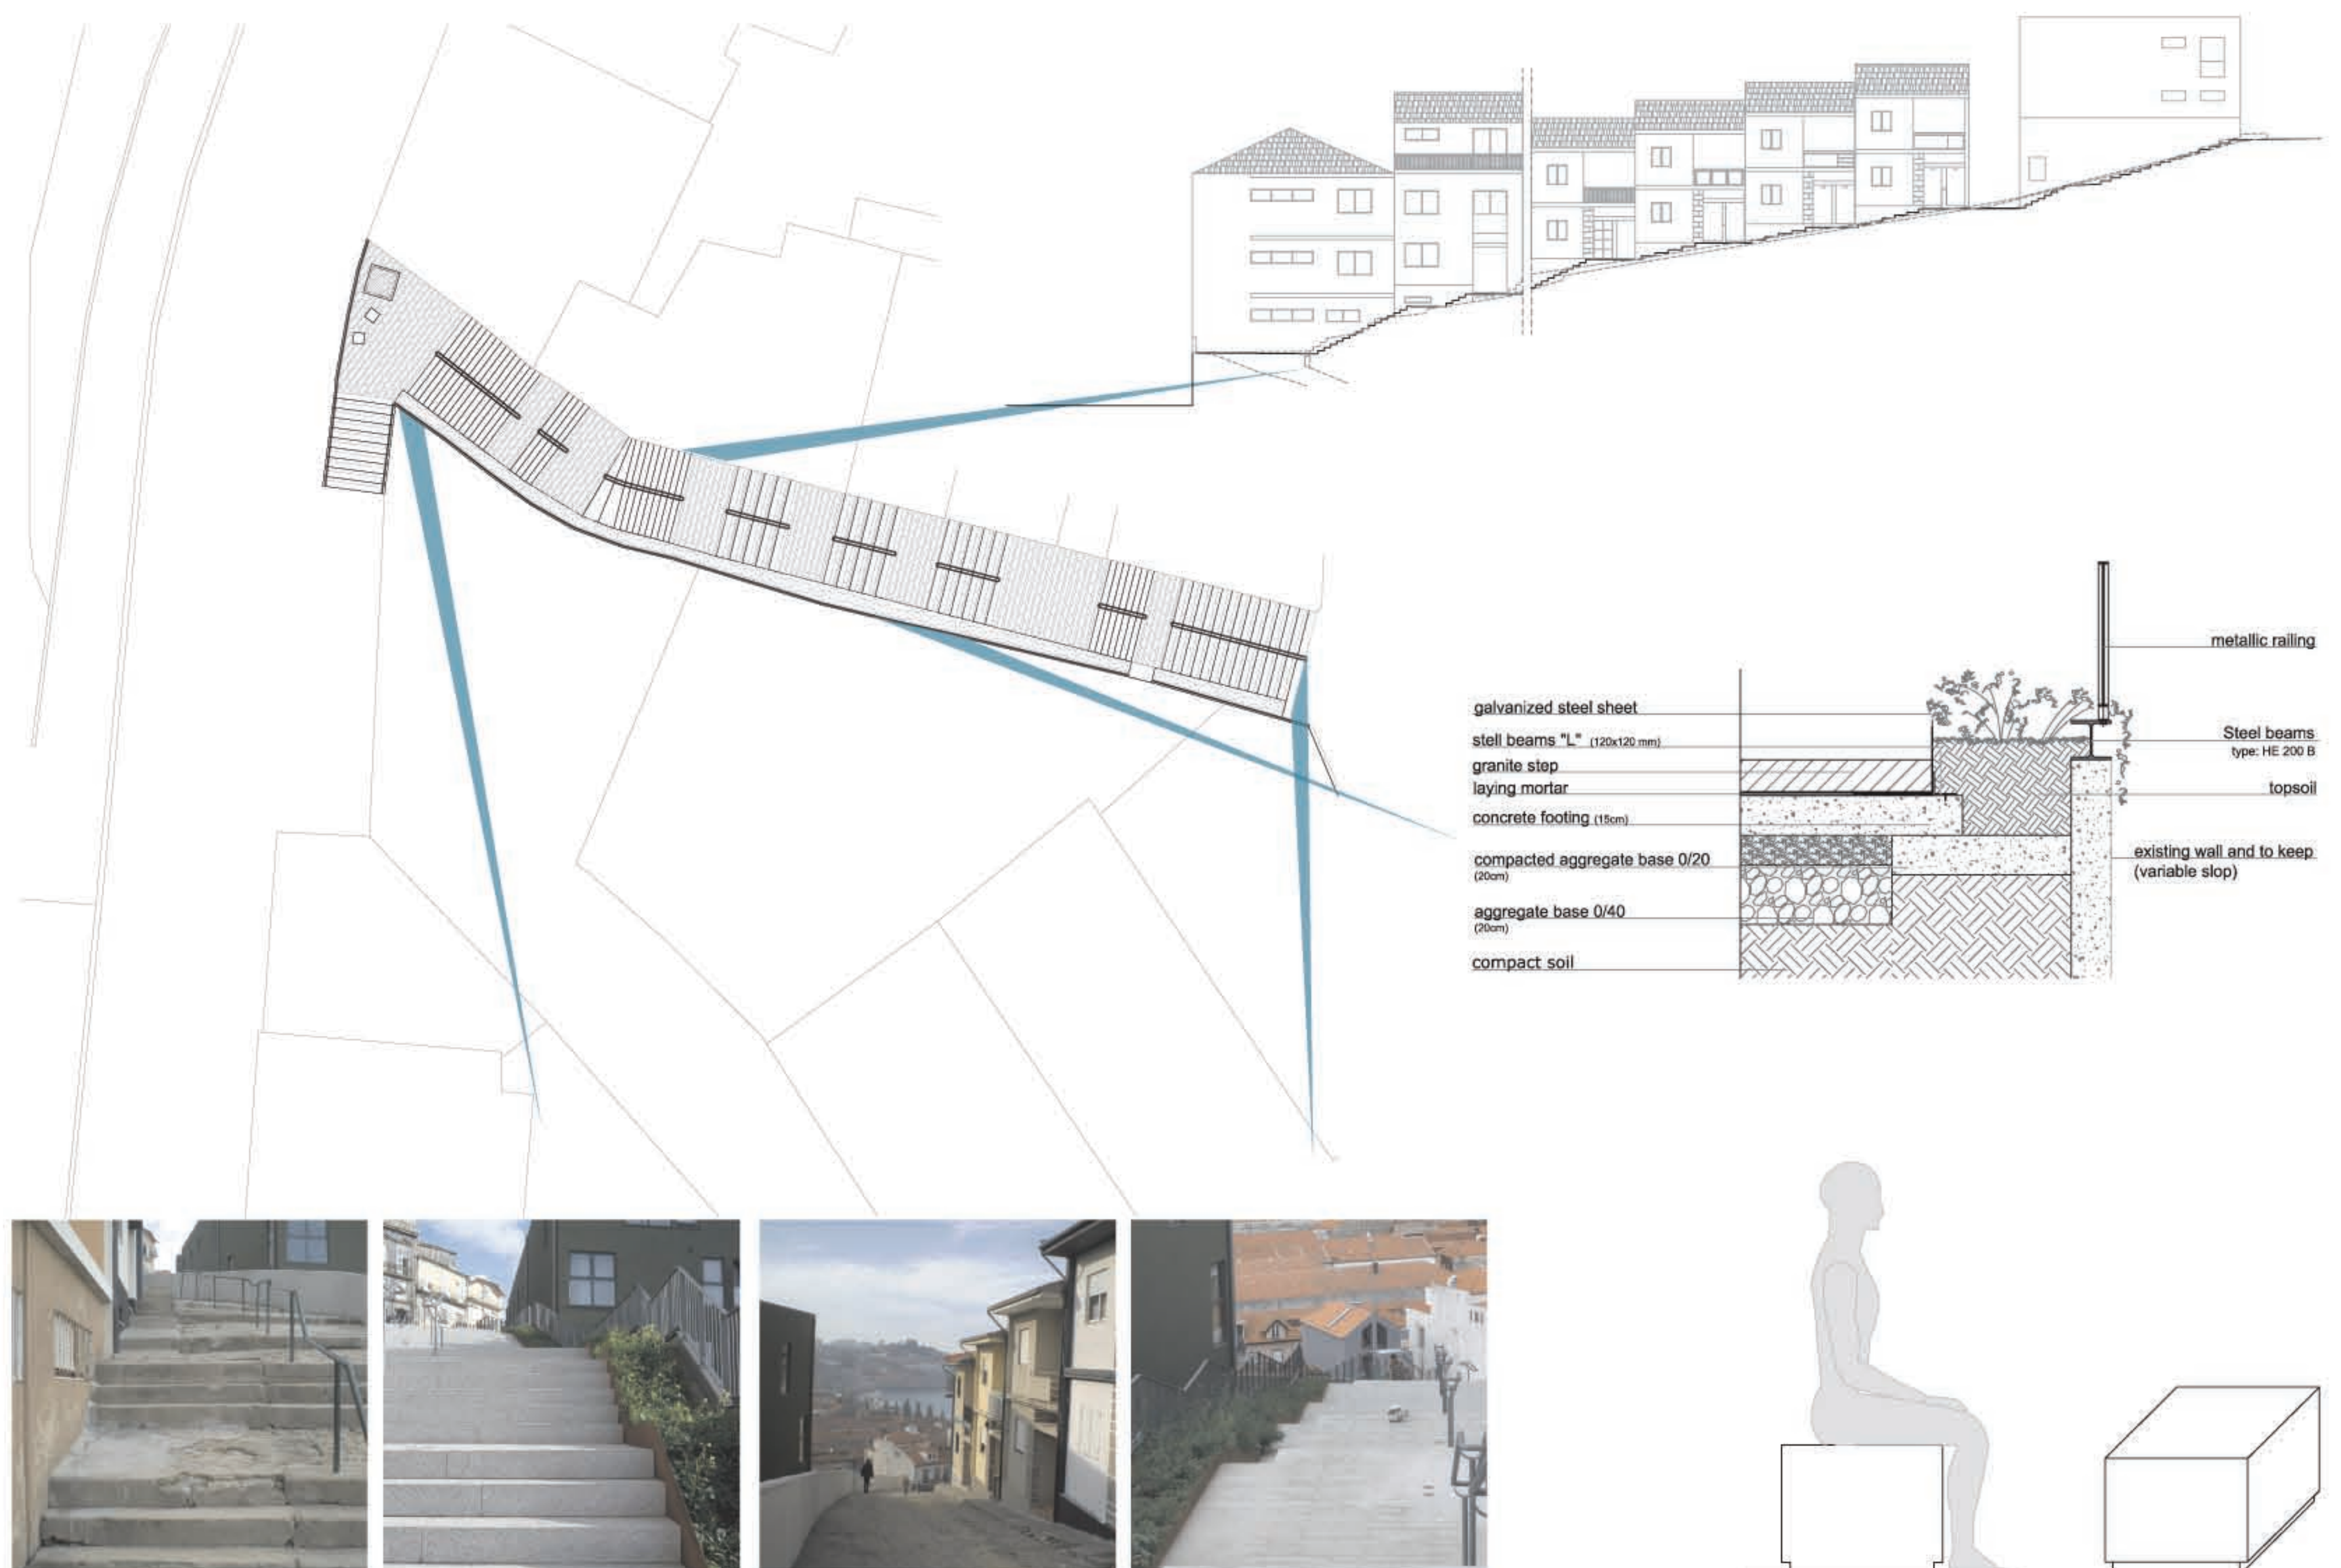
ESCADAS DO PEDROSA

PRE-EXISTENCE

In many sections of its longitudinal axis, the stairs had been replaced by ramps with a very strong slope that delayed walking and the access to the buildings;
Pavement in very bad condition and presence of irregular steps with different heights;

PROPOSAL

Regularization of the steps in order to uniform the heights and create landings of identical dimensions that match the doors/entries of the buildings;
Introduction of a lateral planter along the stairs with decumbent species in order to minimize the impact of the concrete retaining wall, created during the construction of the social house building;
The materials applied are granite slabs in the stairs and corten steel in the planter;
